# **Condition Assessment of William Beaumont General Hospital Historic Buildings at Fort Bliss, Texas**

Thomas R. Napier and Sheila A. McCarthy

September 2002

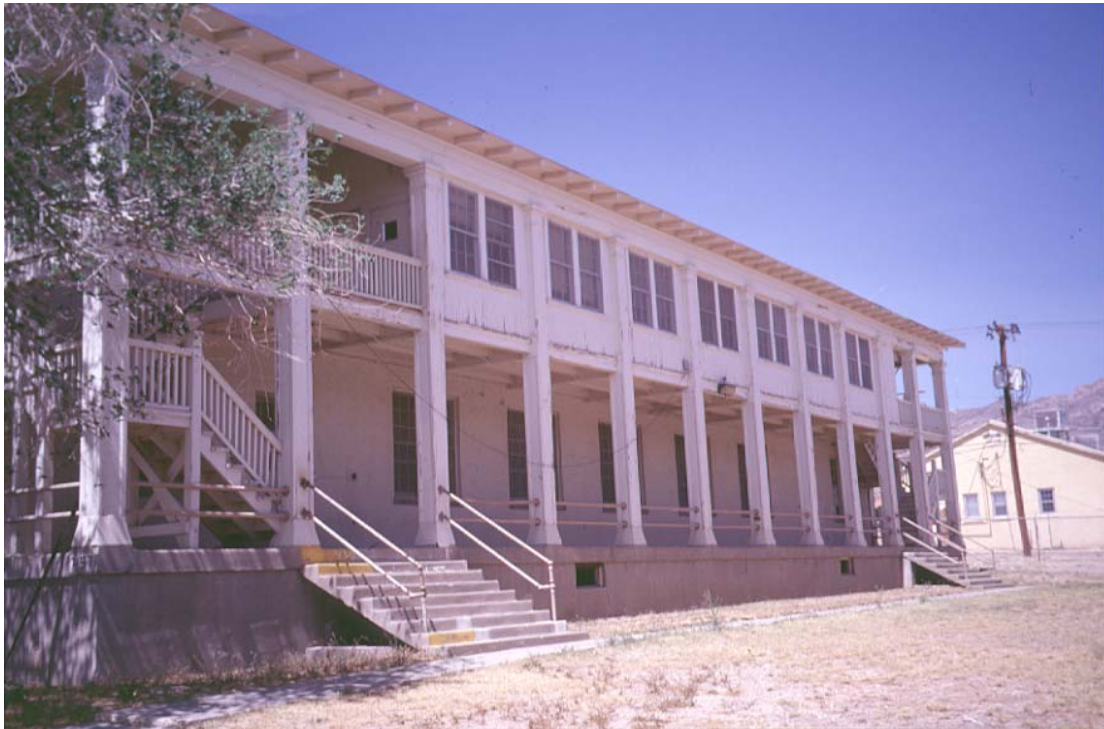
**Photograph 41. Non-historic second-story barracks porch enclosure.**

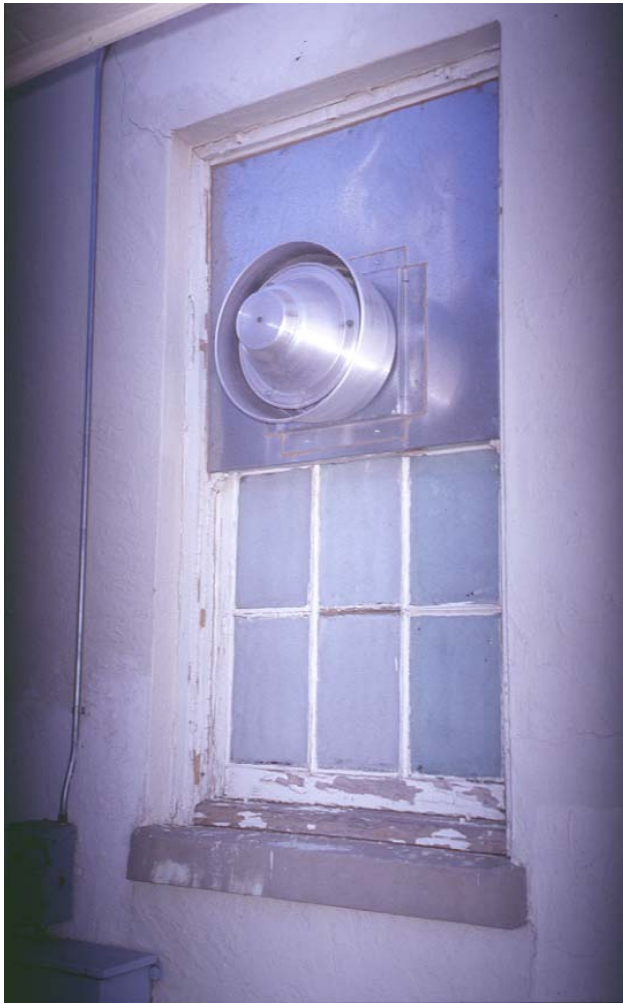
**Photograph 43. Non-historic washroom window modification.**

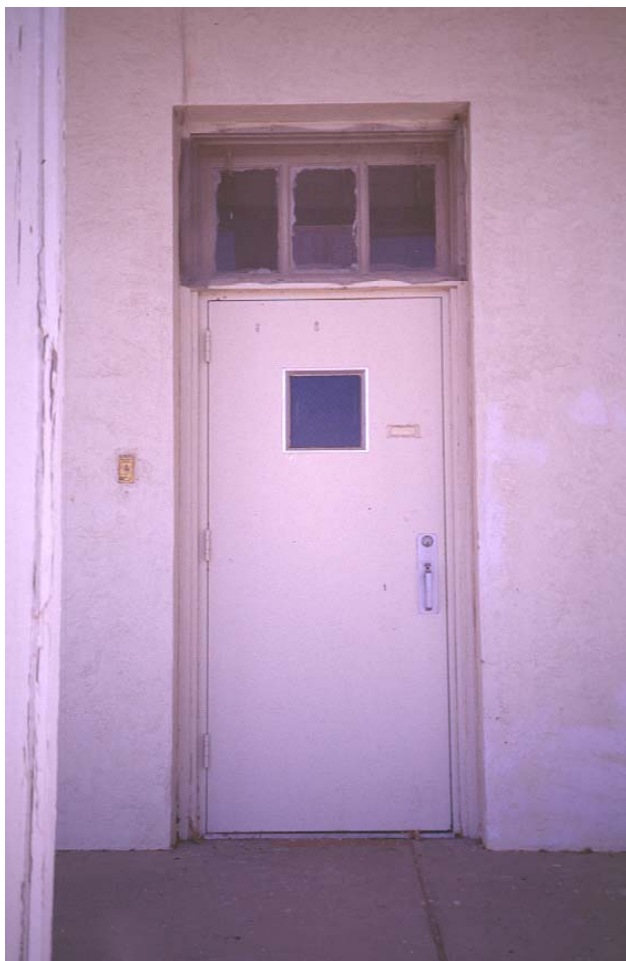
**Photograph 44. Non-historic barracks replacement door.**

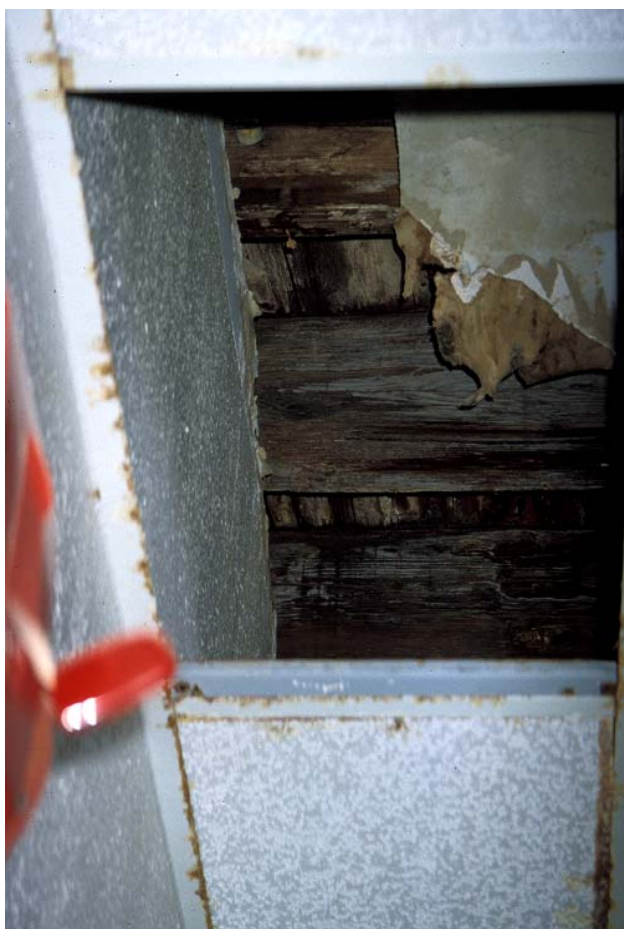
**Photograph 45. Typical water-damaged barracks ceiling in first-floor washroom.**

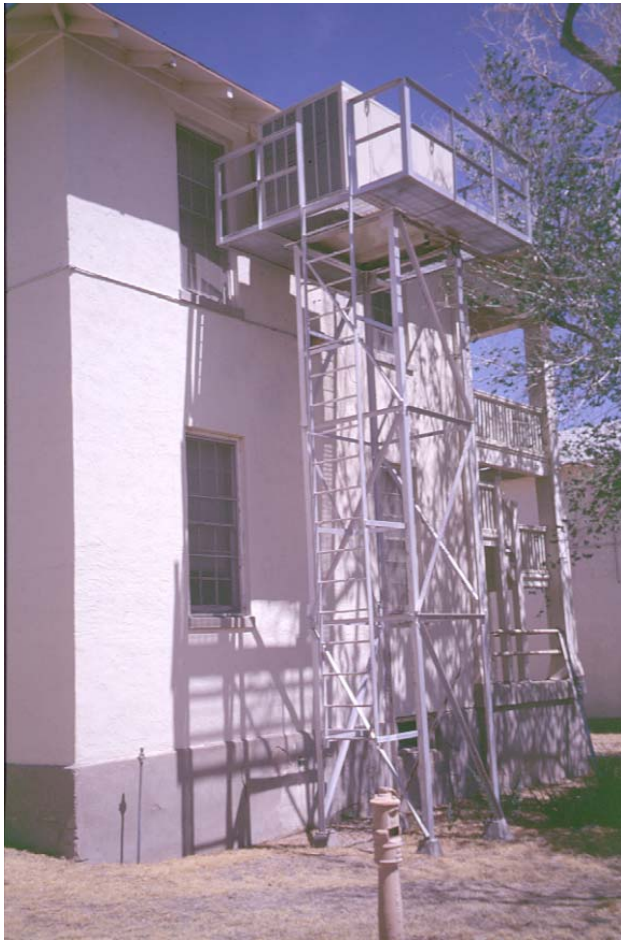
**Photograph 47. Historically inappropriate barracks cooling equipment.**

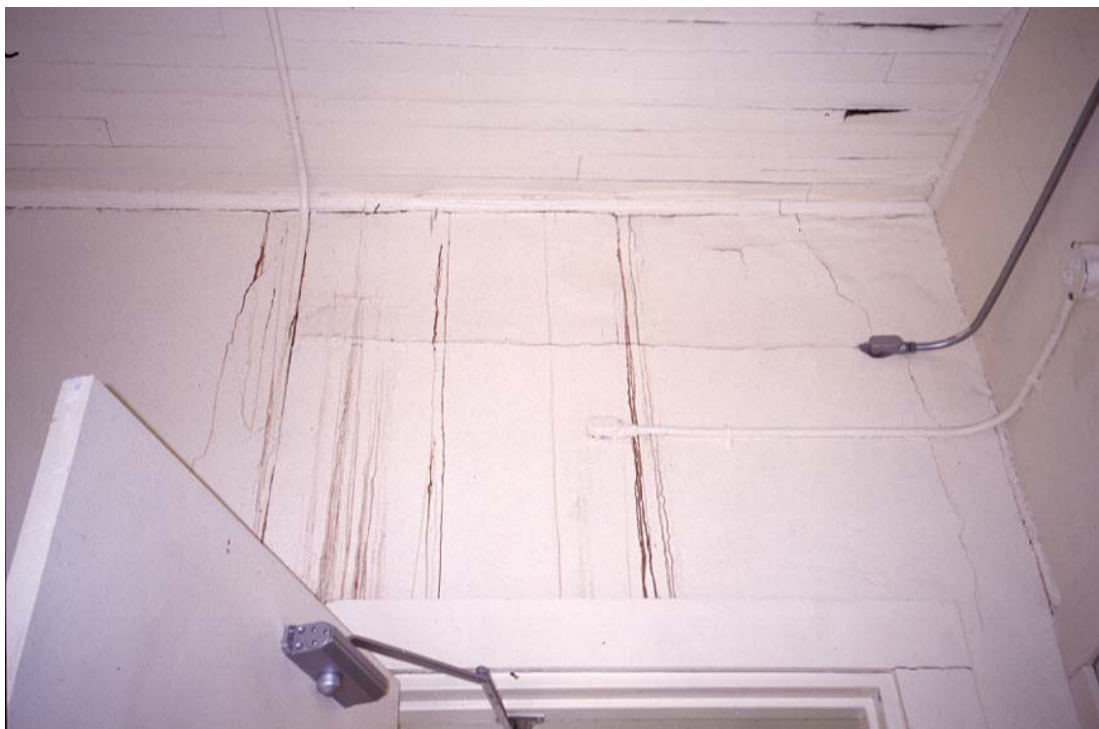
**Photograph 48. Signs of roof leakage in porch of Building 7157.**

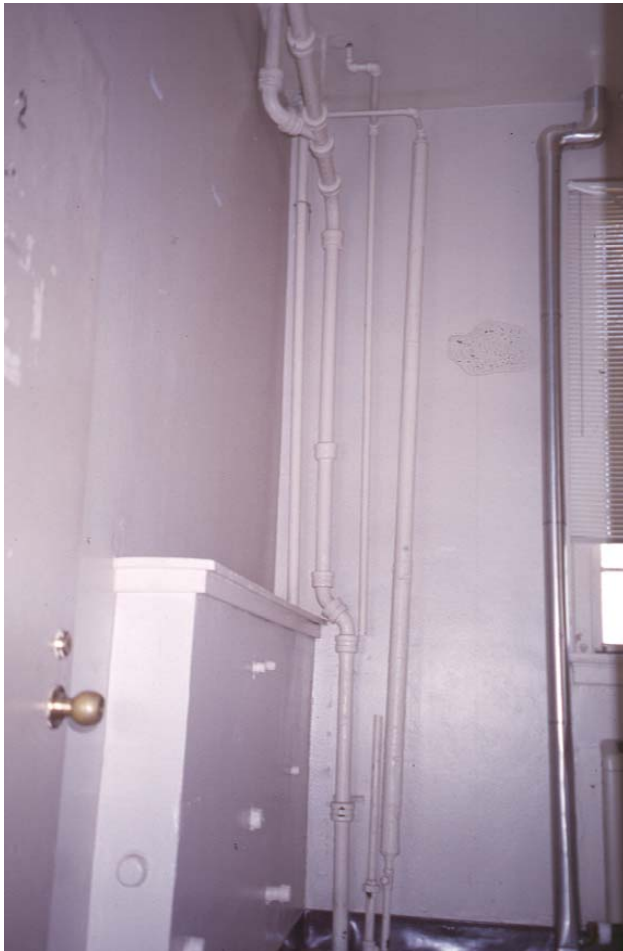
**Photograph 49. Non-historic plumbing modifications in Building 7157.**

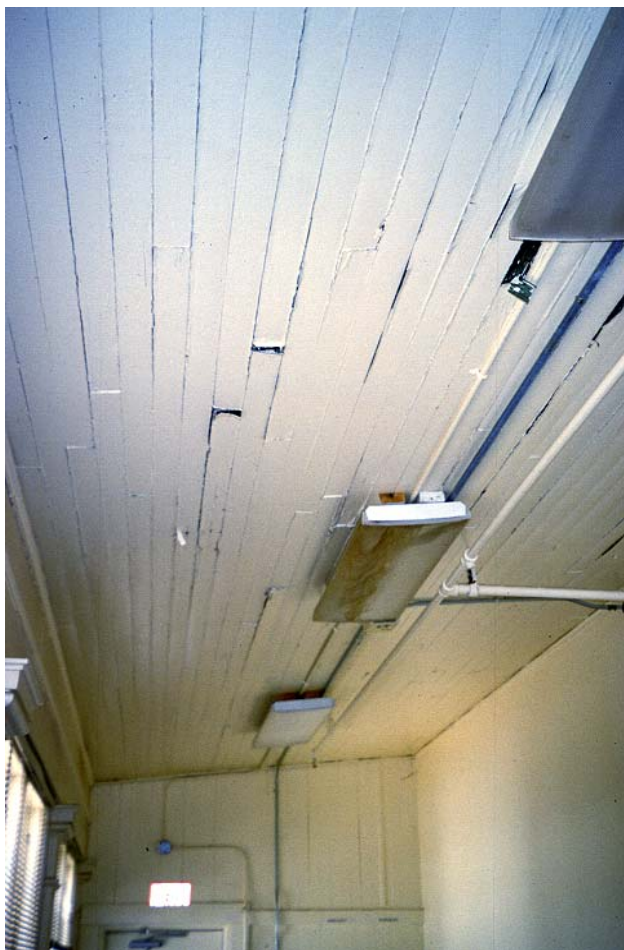
**Photograph 51. Signs of porch roof leakage in Building 7158.**

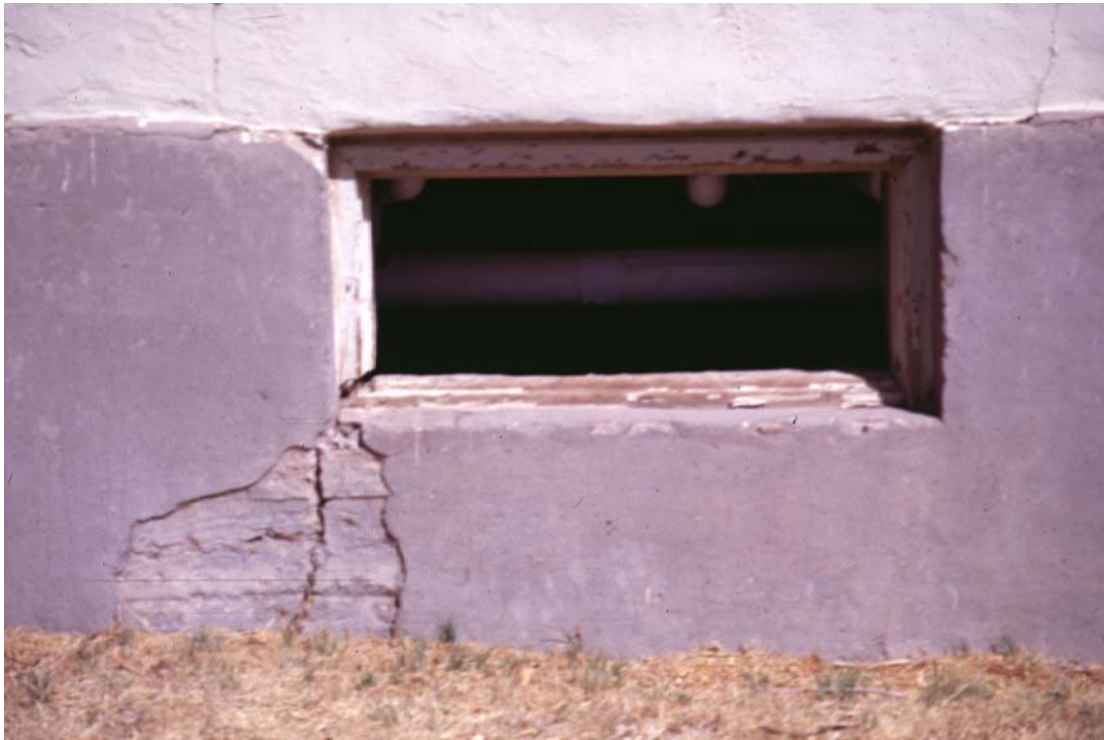
**Photograph 54. Building 7159 foundation crack.**

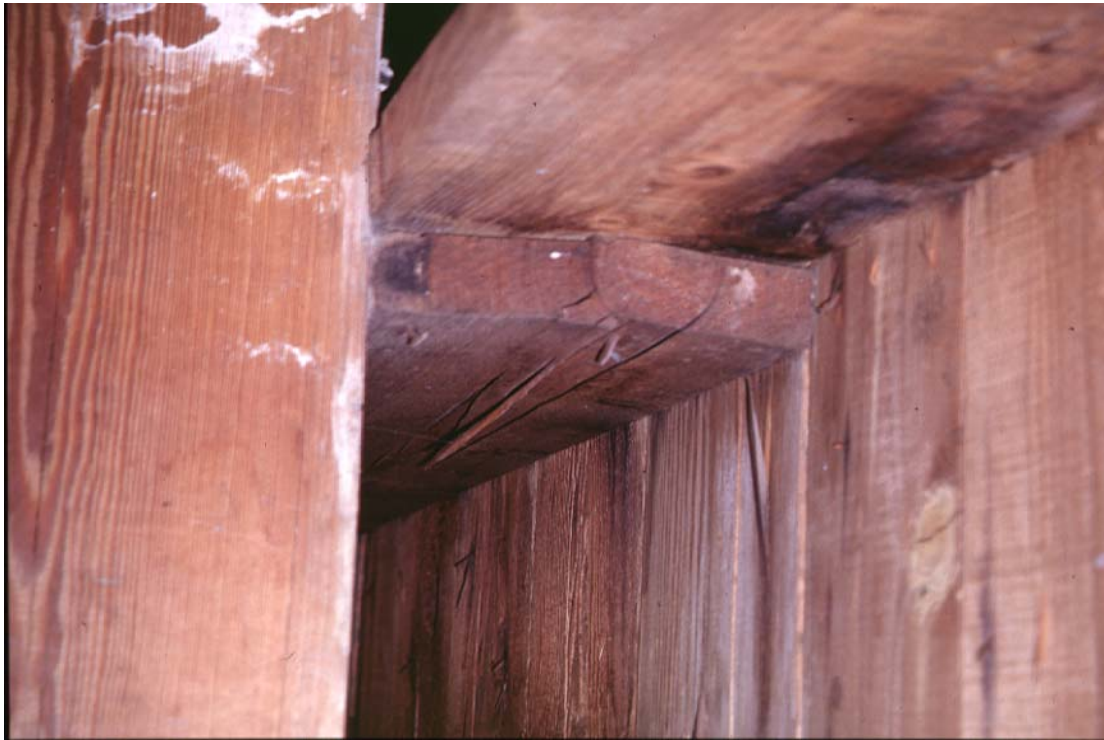
**Photograph 55. Detail of Building 7159 floor joists.**

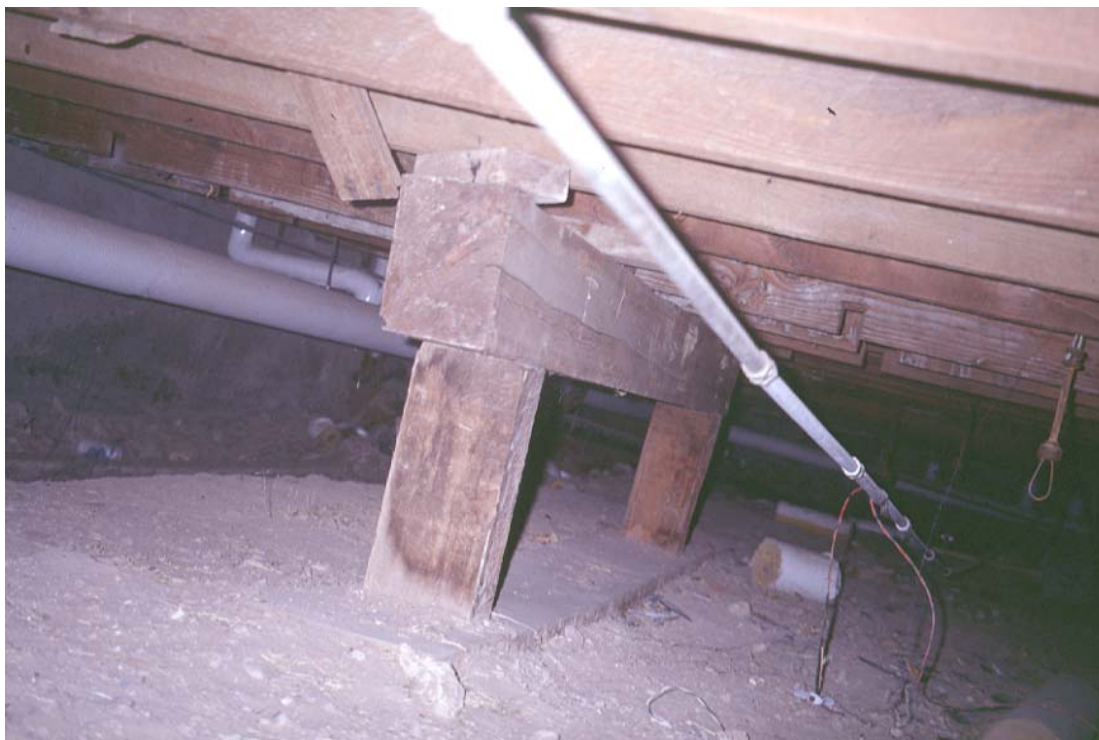
**Photograph 56. Makeshift repair of floor framing under Building 7159.**

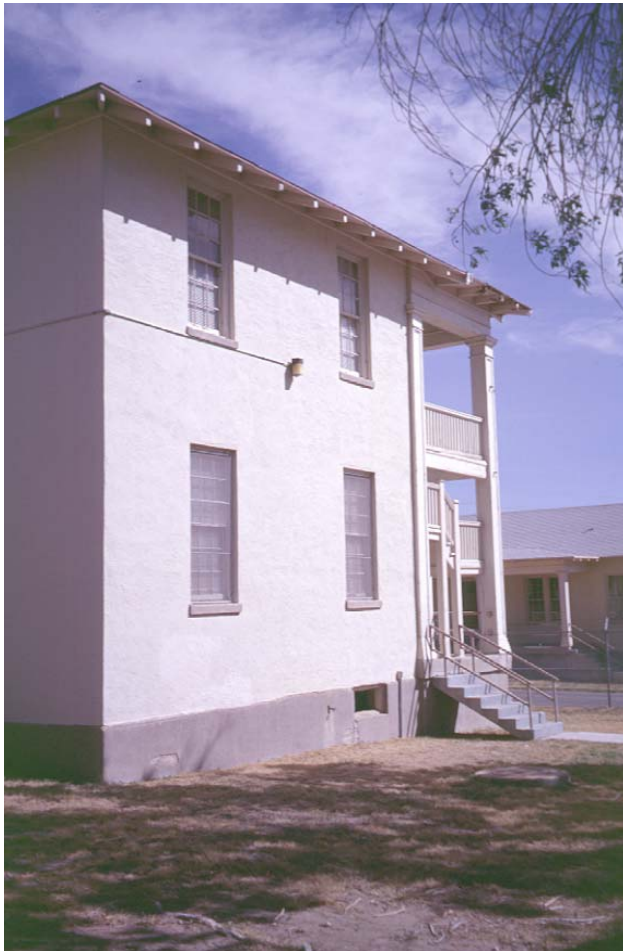
**Photograph 58. Non-historic modification of Building 7159 exterior stairways.**

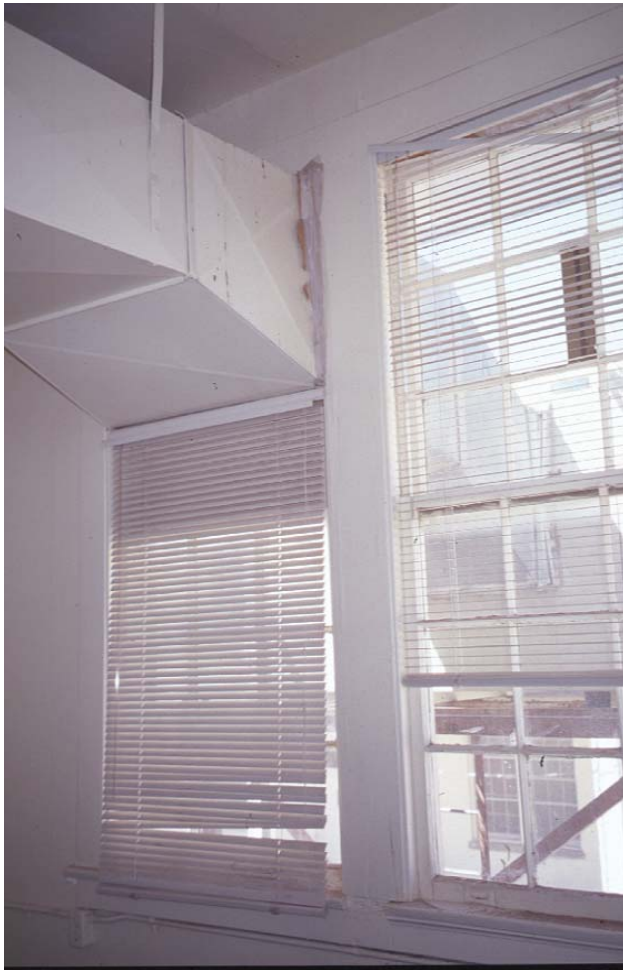
**Photograph 59. Non-historic modification of window sashes in Building 7159.**

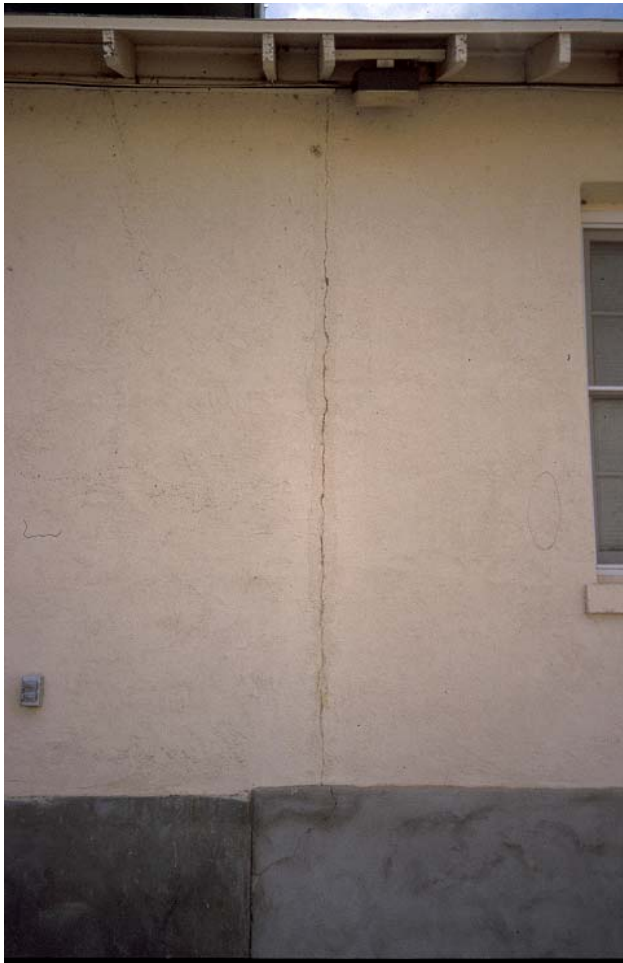
Photograph 61. BOQ foundation and wall crack.

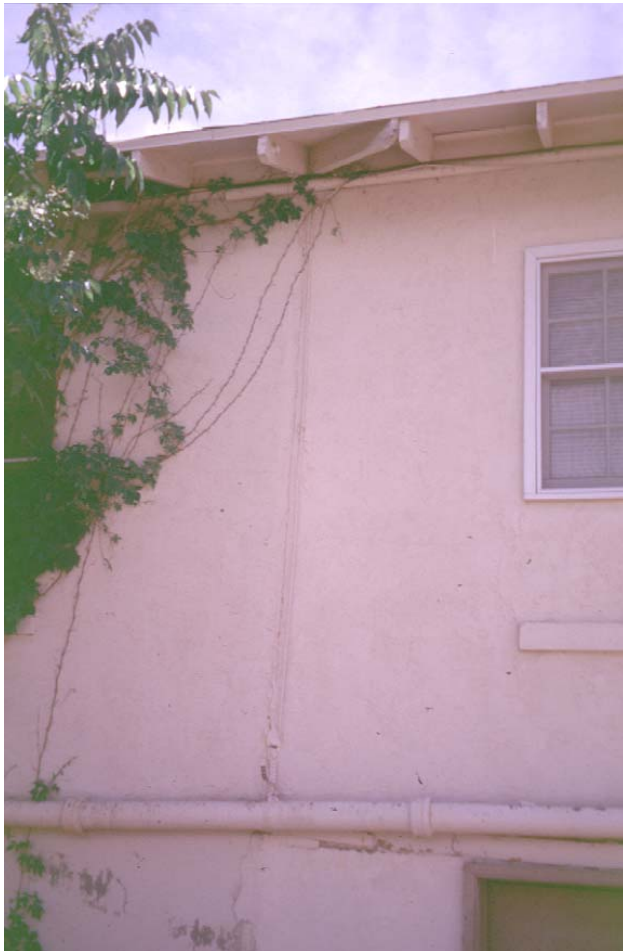
**Photograph 62. Minor BOQ wall crack.**

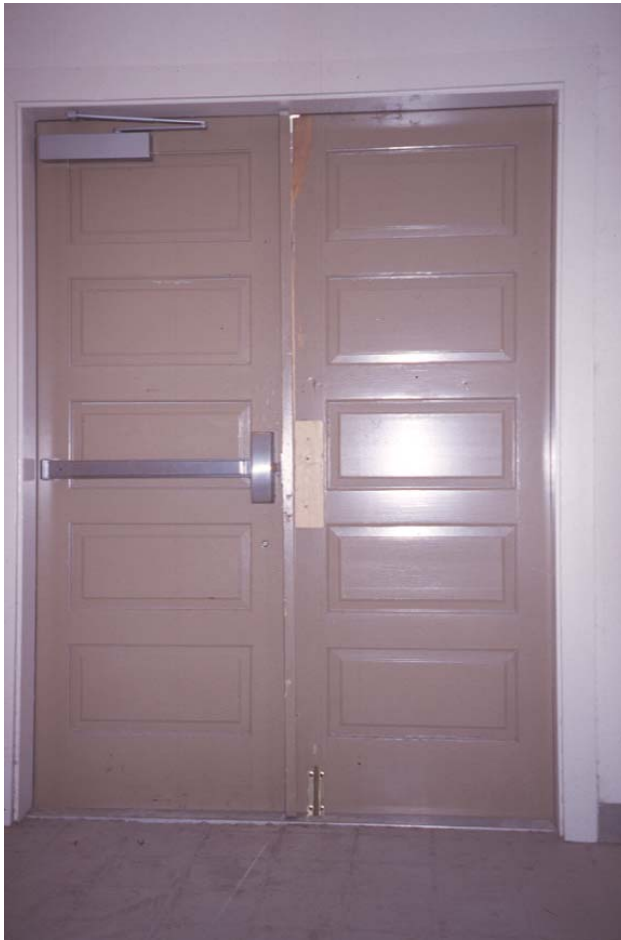
**Photograph 63. Damage to BOQ entry door.**

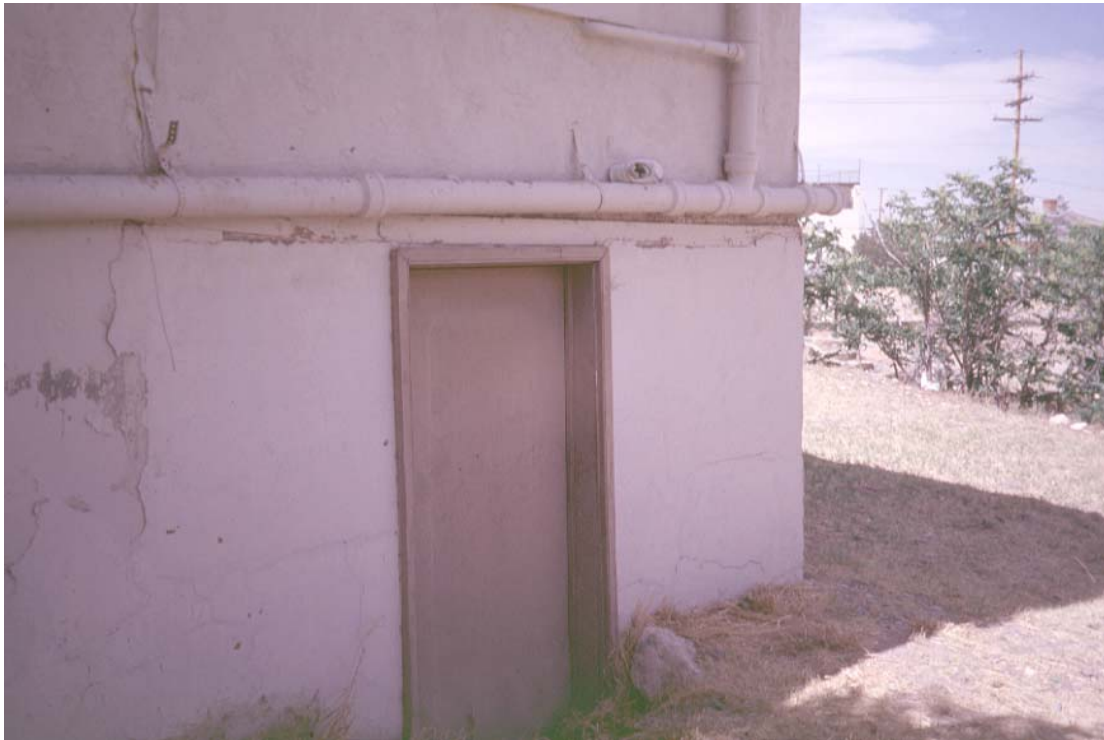
**Photograph 64. Deteriorated BOQ basement door.**

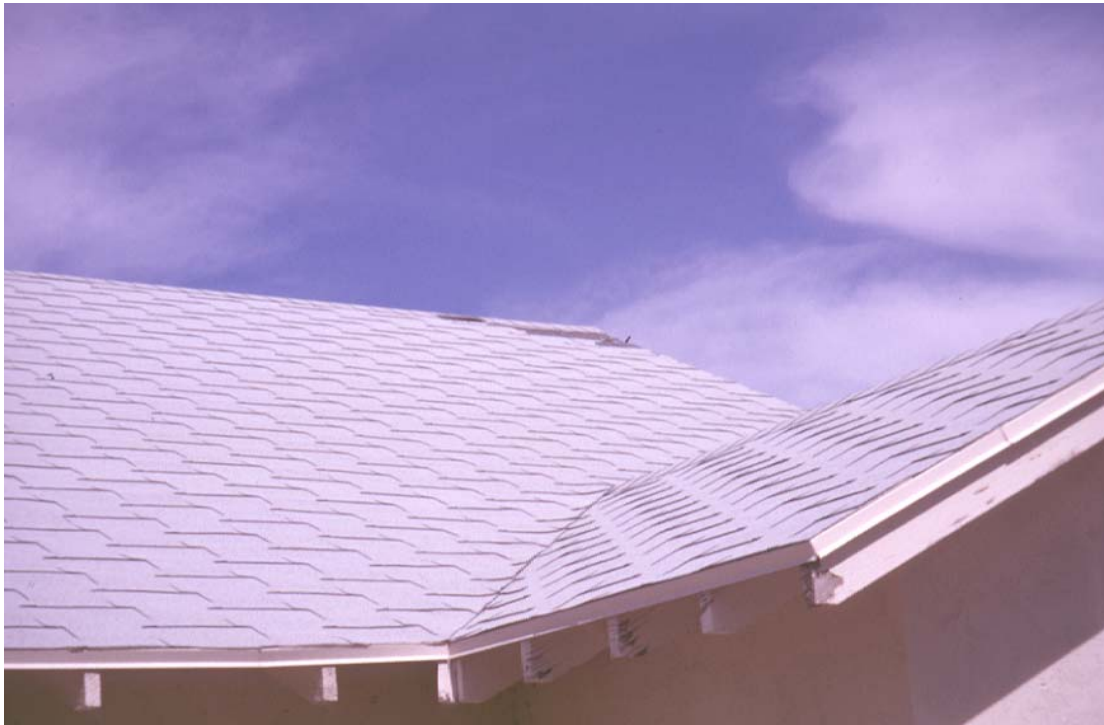
**Photograph 65. Shingles missing on BOQ roof ridge.**

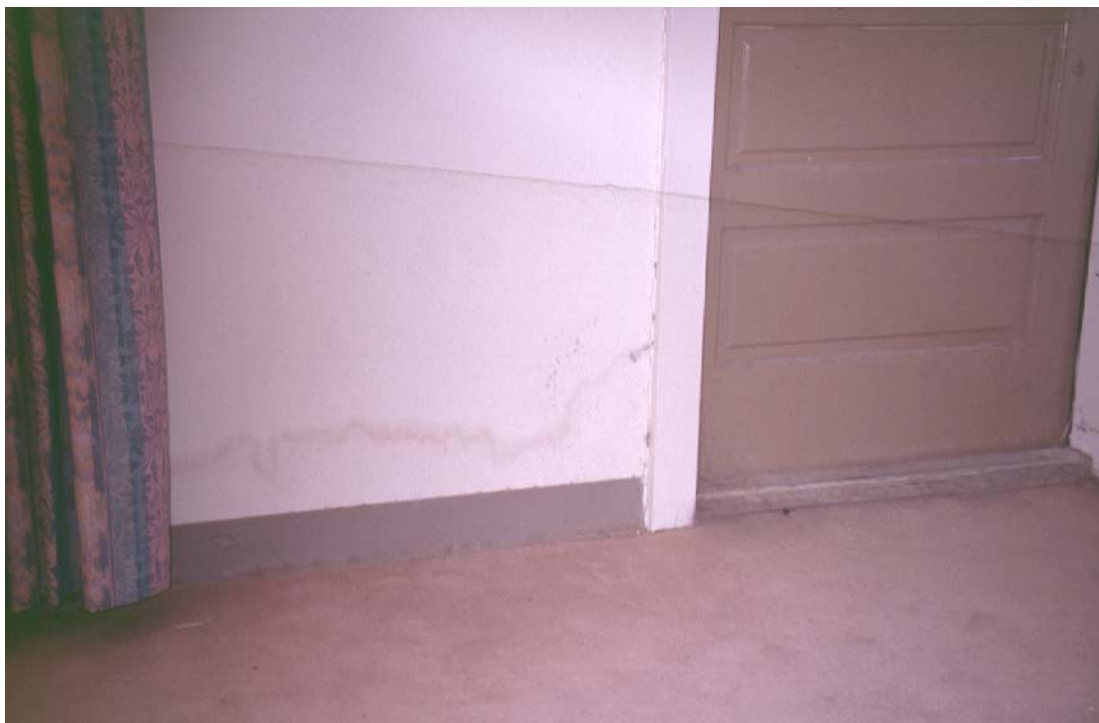
**Photograph 67. Stains on BOQ wallboard indicate leaking exterior walls.**

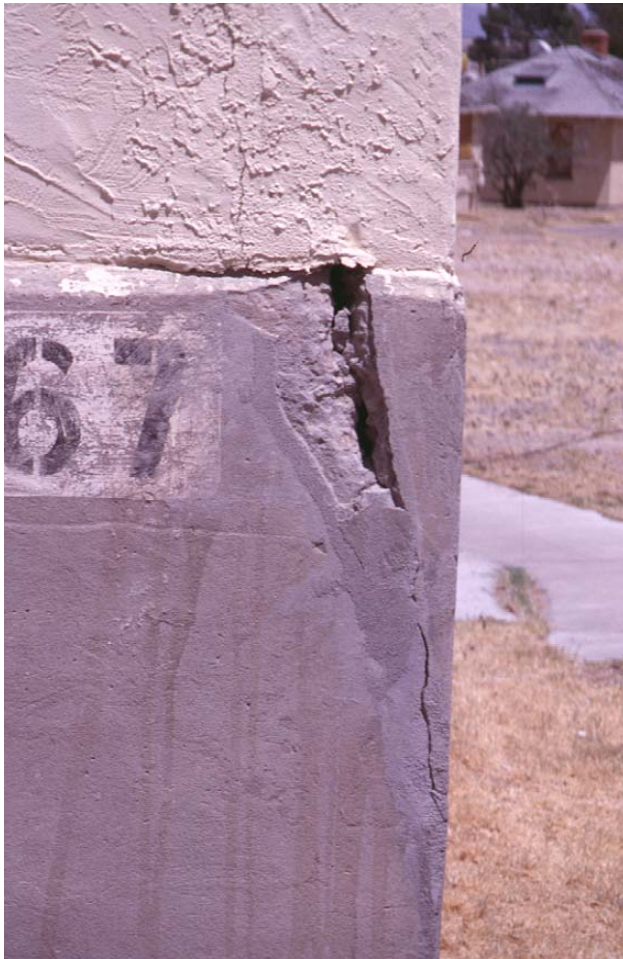
**Photograph 71. Conference center foundation crack.**

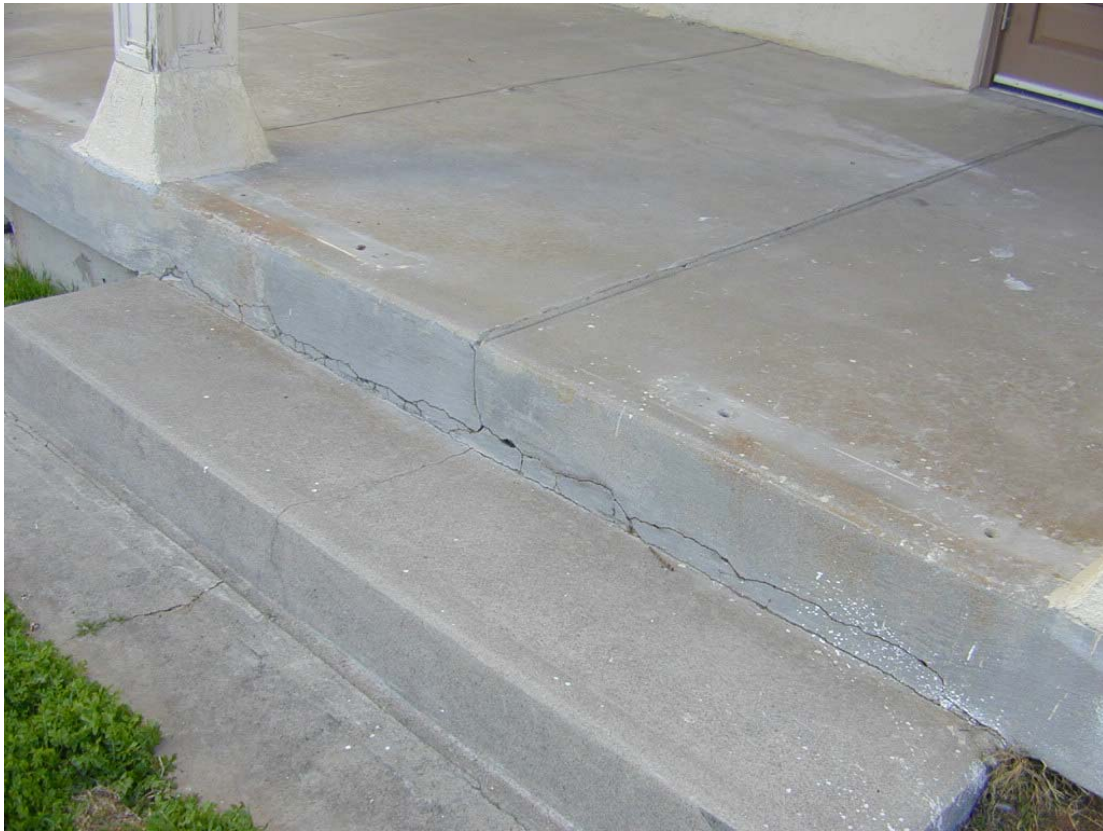
**Photograph 72. Crack in north porch slab of Conference Center.**

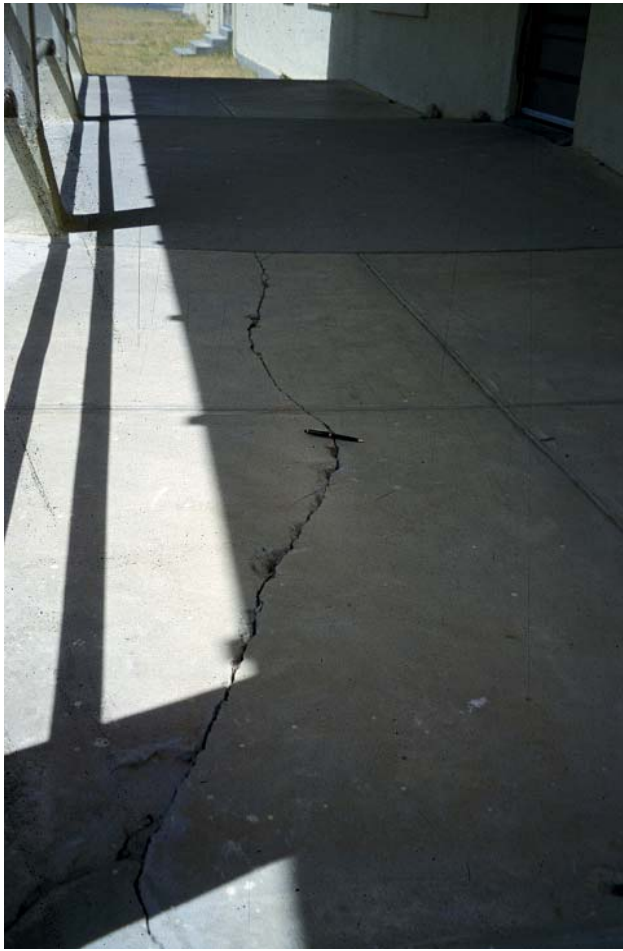
**Photograph 73. Crack in west porch of Conference Center.**

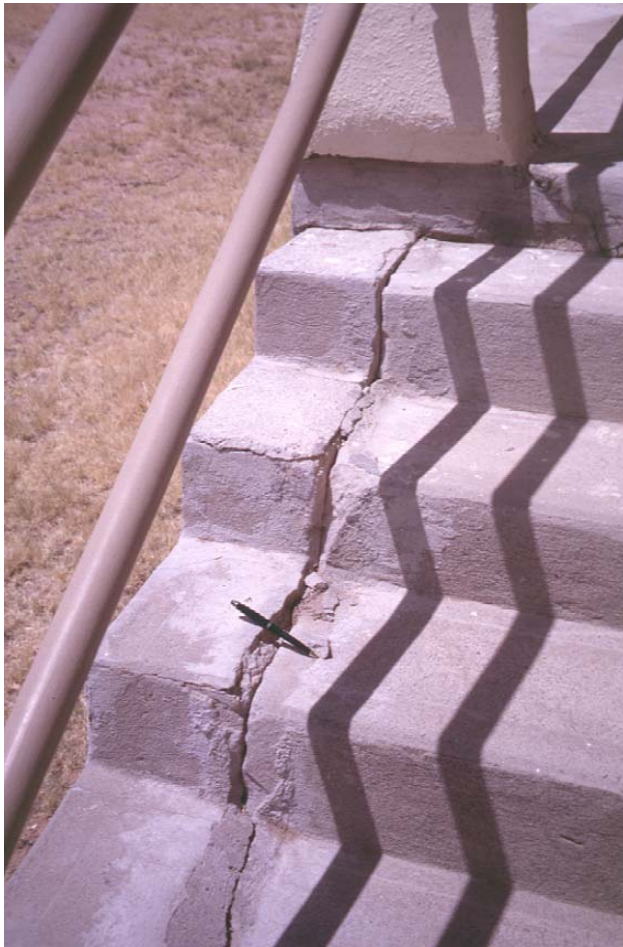
**Photograph 74. Badly cracked Conference Center stairs.**

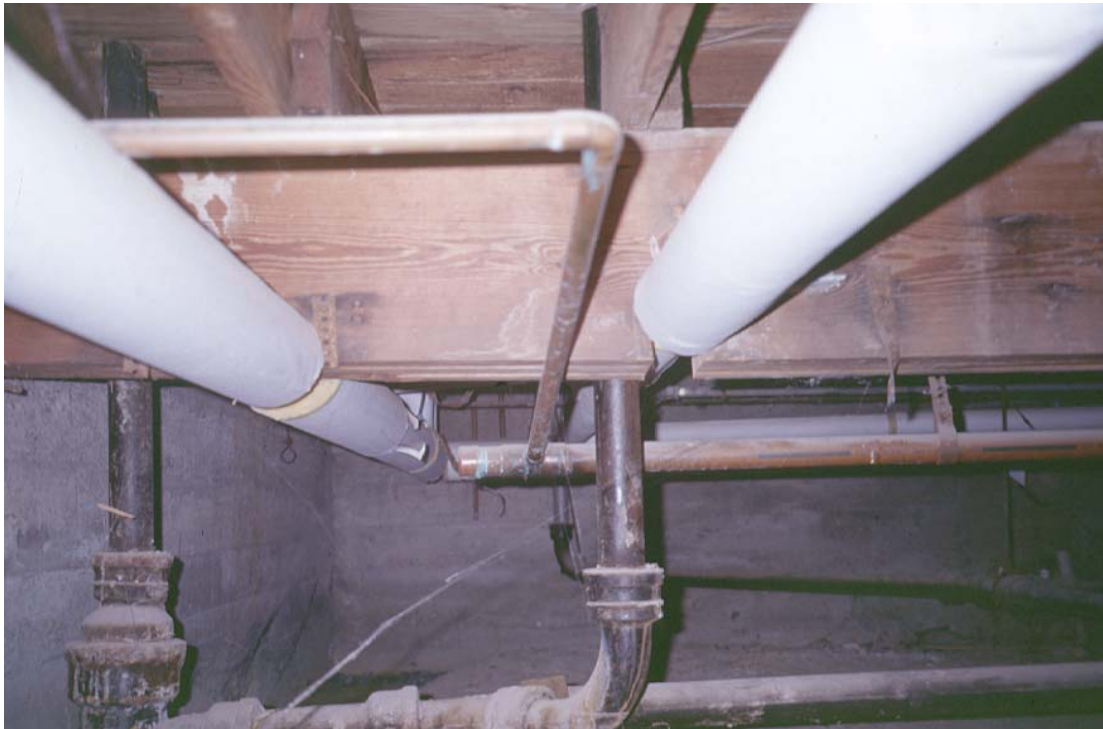
**Photograph 75. Notched floor beam in Conference Center crawl space.**

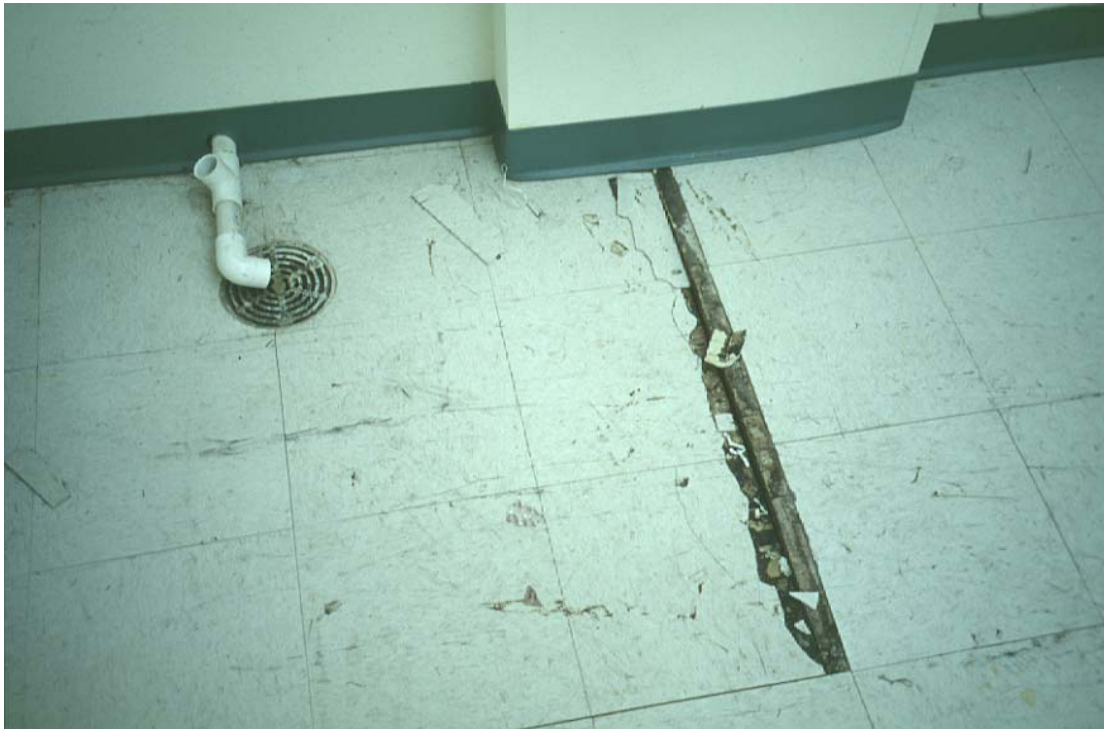
**Photograph 76. Spongy floor area on Conference Center utility room.**

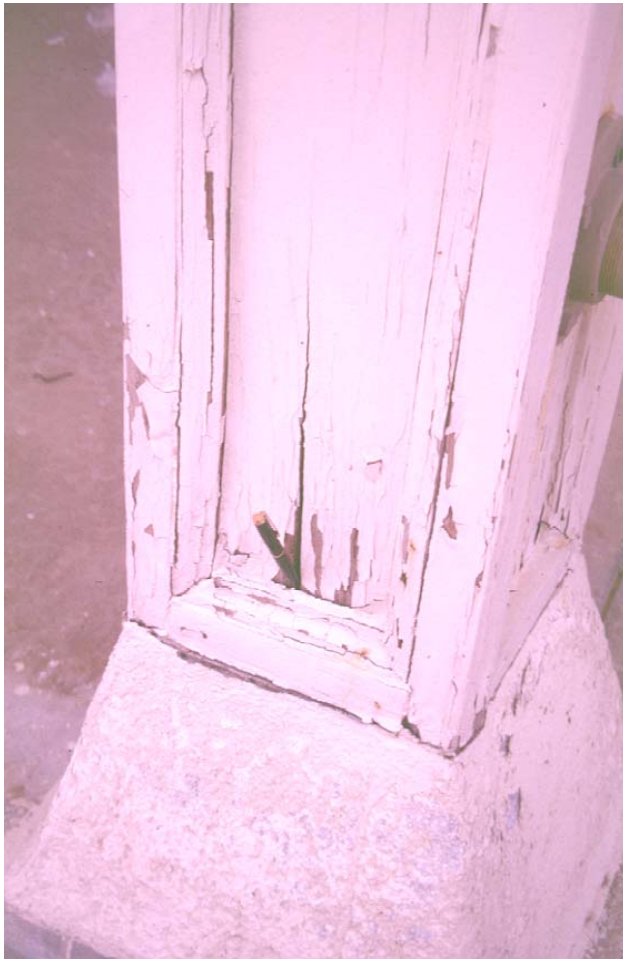
Photograph 78. Split trim work on Conference Center's porch columns.

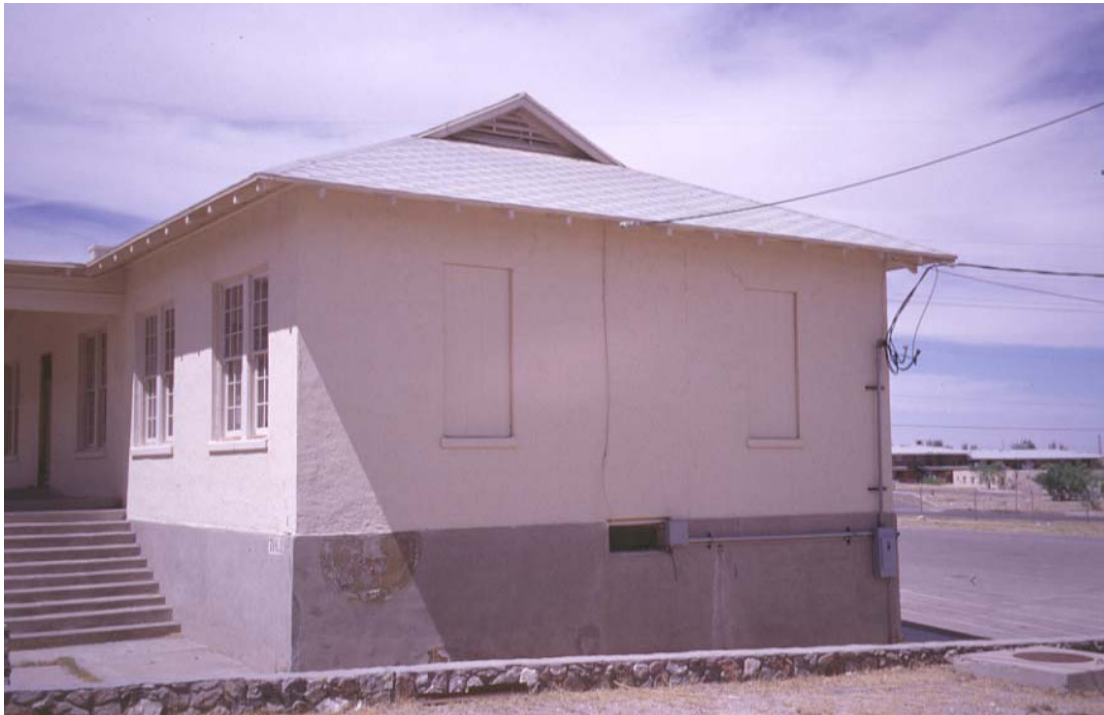
**Photograph 80. Boarded windows in the south wall of Conference Center.**

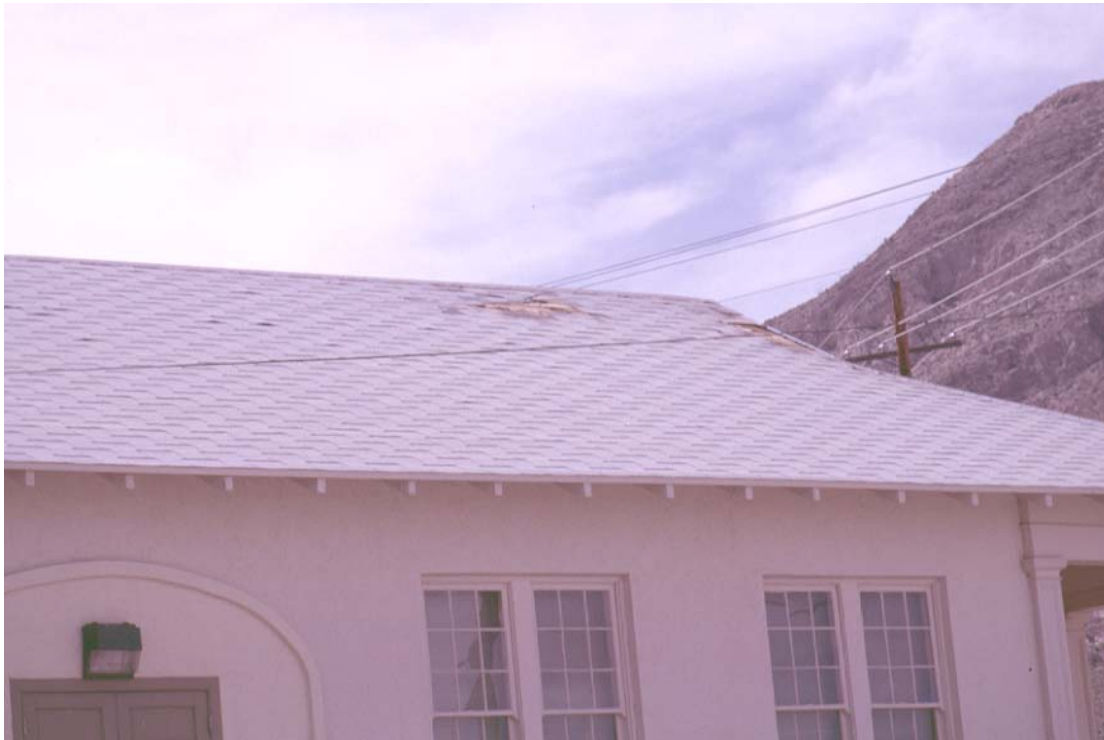
**Photograph 81. Missing shingles on Conference Center.**
